TILECOAT[®] Est. 1972

ROOF SURFACE RESTORATION SYSTEMS

THE STORM!!!

Following the storm an inspection was conducted on three asbestos cement roofs installed on residential housing in the same street at Wavell Heights.

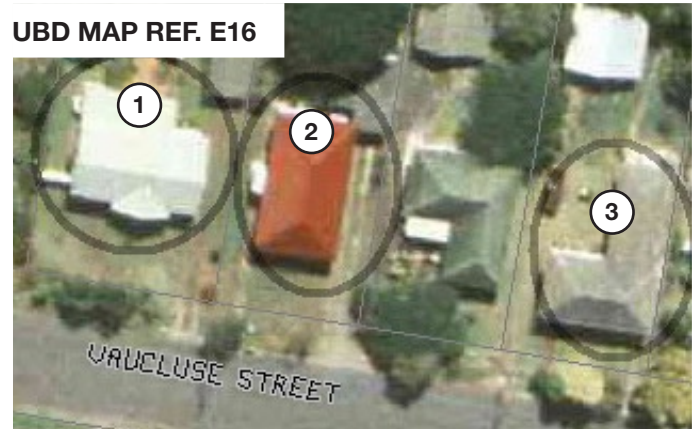
at 29 Vauclose St Wavell Heights: This roof was treated with Tilecoat Epoxy Encapsulation in May 1998. There was no visible abrasion and the coating remained in good condition. The distribution of asbestos contaminated material had been prevented.

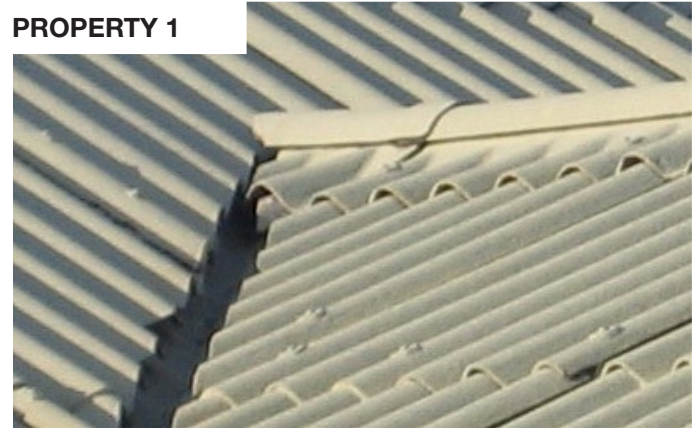
27 Vauclose St Wavell Heights: This roof had been painted with another company's paint process that involved chemical precleaning and priming. The coating was visibly chipped off by the hail. While debris was evident in guttering, the distribution of asbestos contaminated material had been limited.
